Packet Spilling of Small Packets After Parity Error/Bad Address for UT200SpW4RTR SpaceWire Router

Table 1: Cross Reference of Applicable Products

Product Name:	Manufacturer Part Number	SMD #	Device Type	Internal PIC*
4-PORT SPACEWIRE ROUTER	UT200SpW4RTR	NA Note 1	NA	WD41A

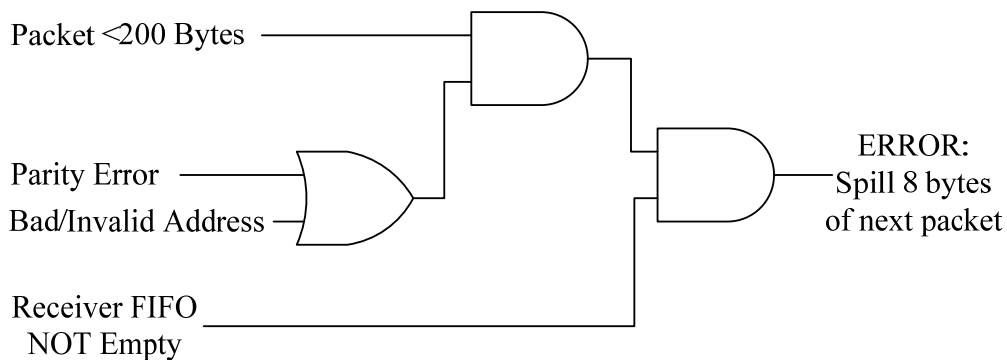
Figure 1. Logic Diagram of Anomaly

The conditions that will cause the anomaly are a small packet (less than 200 bytes), and a parity error occurs in the look up table space (0x0020 – 0x00FF), or a bad/invalid address (per ESCC-E-ST-50-12C section 11.3.4), combined with the internal receive FIFO flag for the target port being not empty. It should be noted that if a parity error in the look up table space occurs the user should rewrite the look up table configuration space (0x0020 to 0x00FF). See Figure 1 for failure logic diagram.

The conditions described will cause 8 bytes of the packet following the error packet to be spilled. There is a chance that the router will continue to spill 8 bytes of a packet following an error packet if parity errors and bad addresses are continuously sent.

Based on preliminary data the probability of this anomaly occurring is once every 9,800 years with the UT200SpW4RTR in operation in a geosynchronous orbit and the Adam's 90% worst case environment.

This anomaly can be prevented by ensuring that the packets on the SpW network are larger than 200 bytes, ensuring that there are no Parity Errors, or Bad Address packets on the network. If the anomaly is encountered two options are offered that will recover the UT200SpW4RTR into normal operation.
